Orthodontic treatment of a mandibular incisor fenestration resulting from a broken retainer

This article describes the orthodontic relapse with mandibular incisor fenestration in a 36-year-old man who had undergone orthodontic treatment 21 years previously. The patient reported that his mandibular 3 × 3 bonded retainer had been partially debonded and broken 4 years earlier. The mandibular left lateral incisor remained bonded to the retainer and received the entire load of the incisors; consequently, there was extreme labial movement of the root, resulting in dental avulsion. As part of the treatment, the root was repositioned lingually using a titanium-molybdenum segmented archwire for 8 months, followed by endodontic treatment, an apicoectomy, and 4 months of alignment and leveling of both arches. The treatment outcomes were excellent, and the tooth remained stable, with good integrity of the mesial, distal, and lingual alveolar bones and periodontal ligament. The 1-year follow-up showed good stability of the results. (*Am J Orthod Dentofacial Orthop* 2015;148:332-7)

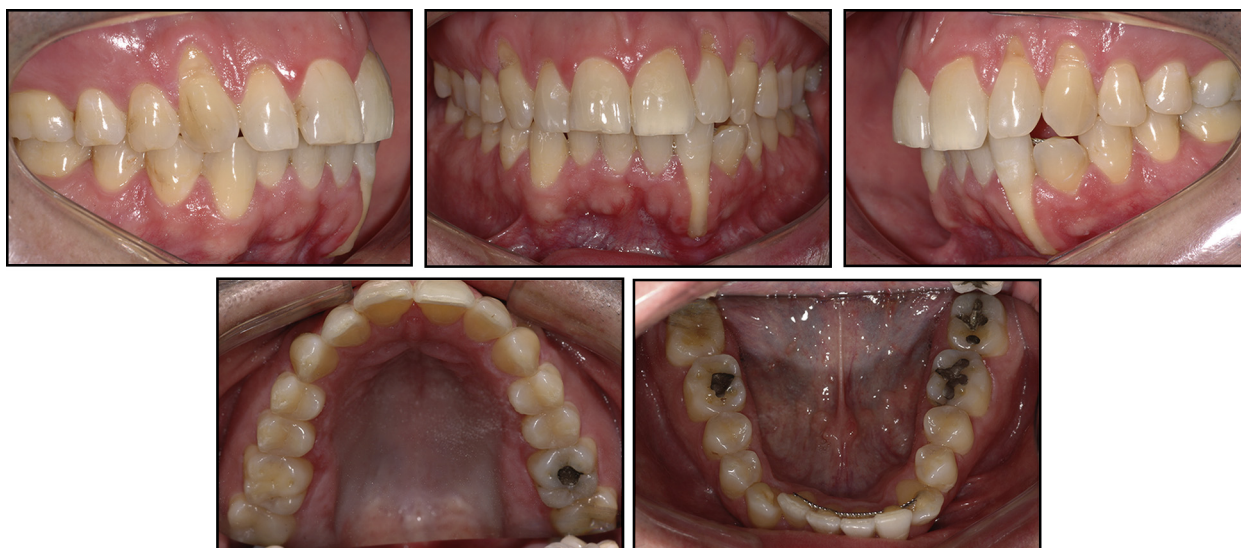
The clinical examination showed that the bonded retainer was broken between the mandibular right lateral incisor and the canine. Furthermore, the right lateral incisor and the right central incisor had moved lingually; consequently, the left canine had moved labially. In the initial clinical examination, we verified that the

Fig 1. Initial intraoral photographs.

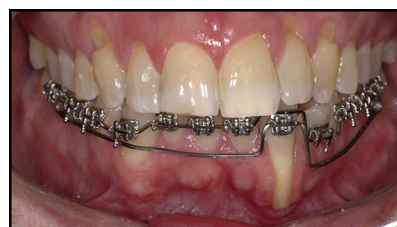
Fig 3. Segmented mechanics with 0.019 × 0.025-in titanium-molybdenum archwire connected only to the lateral incisor.

For repositioning the tooth, 0.022×0.028 -in edge-wise standard brackets were bonded only in the mandibular arch. First, a passive 0.021×0.025 -in stainless steel archwire was inserted in all brackets except that of the mandibular left lateral incisor. Thereafter, the lingual torque of the root was corrected with a 0.019×0.025 -in titanium-molybdenum wire connected only to the bracket of the mandibular left lateral incisor and activated in 10 g of force in the posterior region between the mandibular second premolars and the first molars on both sides (Fig 3). Because there was about 30 mm of distance between the lateral incisor and the point where the force was applied, a system with a moment of about 300 g of force per millimeter acting over the root was developed. The archwire for torque movement was activated every month for 5 months. By the fifth month, the apex was totally covered with soft tissue; consequently, the apicoectomy was performed (Fig 4). Thereafter, a maxillary orthodontic appliance was bonded, and alignment and leveling were performed for both arches from 0.014 -in to 0.019×0.025 -in stainless steel archwires, along

Machado et al¹¹ used a continuous archwire to move an incisor root lingually to reduce a moderate recession. To increase the interbracket distance, they did not bond the adjacent teeth and used a continuous archwire of a titanium-molybdenum alloy, creating a more flexible system. In the patient described here, we chose a segmented mechanism rather than a continuous arch because we needed complete control of the force used to torque the root. With a continuous rectangular arch, it would have been impossible to quantify the force used during the activation, whereas the segmented arch allowed precise measurement of the force. Because the patient reported a constantly increasing recession and this labial movement was caused by the incisor guidance, we may consider that this was similar to a system delivering a constant force. Based on that, the option was the segmented titanium-molybdenum arch that can deliver a continuous force over a long time, compared with a continuous arch that delivers an interrupted force.

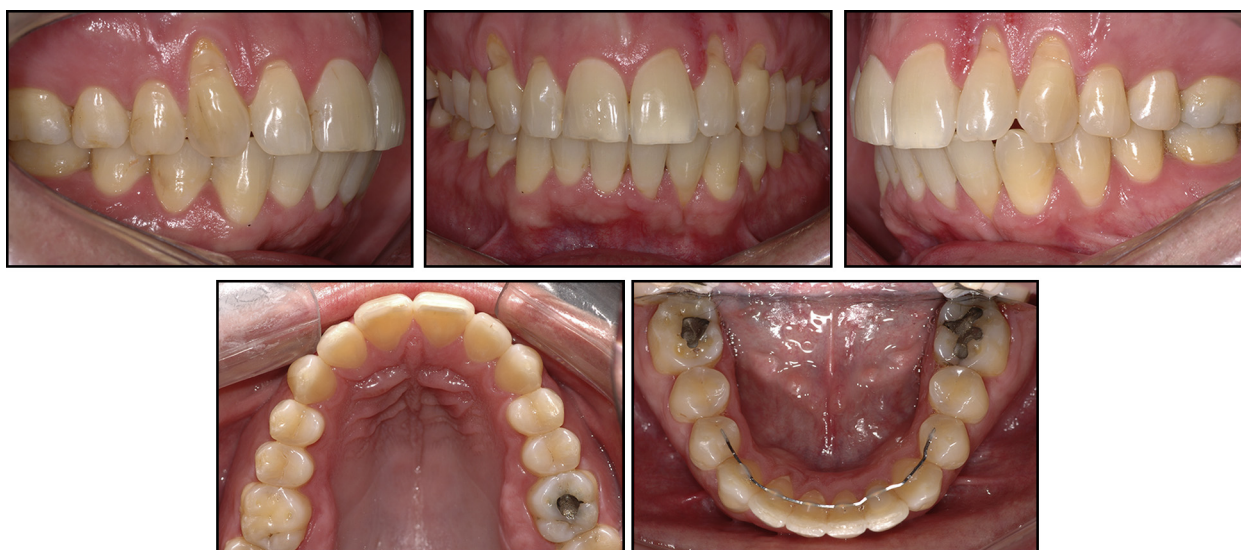
Fig 5. Posttreatment intraoral photographs.

with individual lingual root torque for the mandibular left lateral incisor and labial root torque for the mandibular left canine. After 13 months of treatment and after 1 month of stabilization without activation, the root was completely covered with gingival soft tissue, with only a small gingival defect visible on the labial surface of the root (Fig 5). The posttreatment cone-beam computed tomography (CBCT) image showed that the root was positioned over the alveolar bone and that no regeneration of the buccal wall of the alveolar bone could be achieved. However, some integrity of the mesial and partly of the distal wall surrounding the root was present. The wide alveolar ridge at the level of the mandibular left lateral incisor (Fig 2, A) was resorbed because of the lingual root movement, and only a small part of the lingual wall seemed to be present (Fig 6, A). However, periodontal probing showed a sulcus depth of only 1 mm labially (Fig 6). Finally, a 4×4 retainer of 0.016×0.022 -in stainless steel wire was bonded to the mandibular arch, and the maxillary arch received a wrap-around retainer. At the 1-year follow-up, the results

At the end of the treatment, even without a graft positioned over the root, an excellent gingival pattern was obtained, with minor recession on the buccal surface not accompanied by inflammation. The absence of periodontal pockets was verified by probing after treatment and at 1 year after treatment, also increasing the good prognosis in the long term. This periodontal result after treatment may also result from good gingival width on the buccal surface of the mandibular anterior teeth and good hygiene, without inflammation during and after treatment. Tomographic images in the occlusal view showed bone formation on the mesial, distal, and lingual surfaces of the root of the lateral incisor, thus improving the prognosis of the tooth. The sagittal tomographic image showed a bone defect below the apex, probably caused by the movement of the root through the cortical bone that carried the cortical wall lingually. The mandibular left canine was also repositioned with the apex within the alveolar bone, as seen in the sagittal tomographic image. After debonding, a 4 × 4 retainer made of 0.016 × 0.022-in stainless steel wire was bonded to the 8 anterior teeth, to be used indefinitely as rigid fixation for stabilization of the lateral incisor. Usually, the use of semi-rigid fixation is recommended after traumatic avulsion of teeth to allow periodontal stimulation during function, but it should be used temporarily for up to

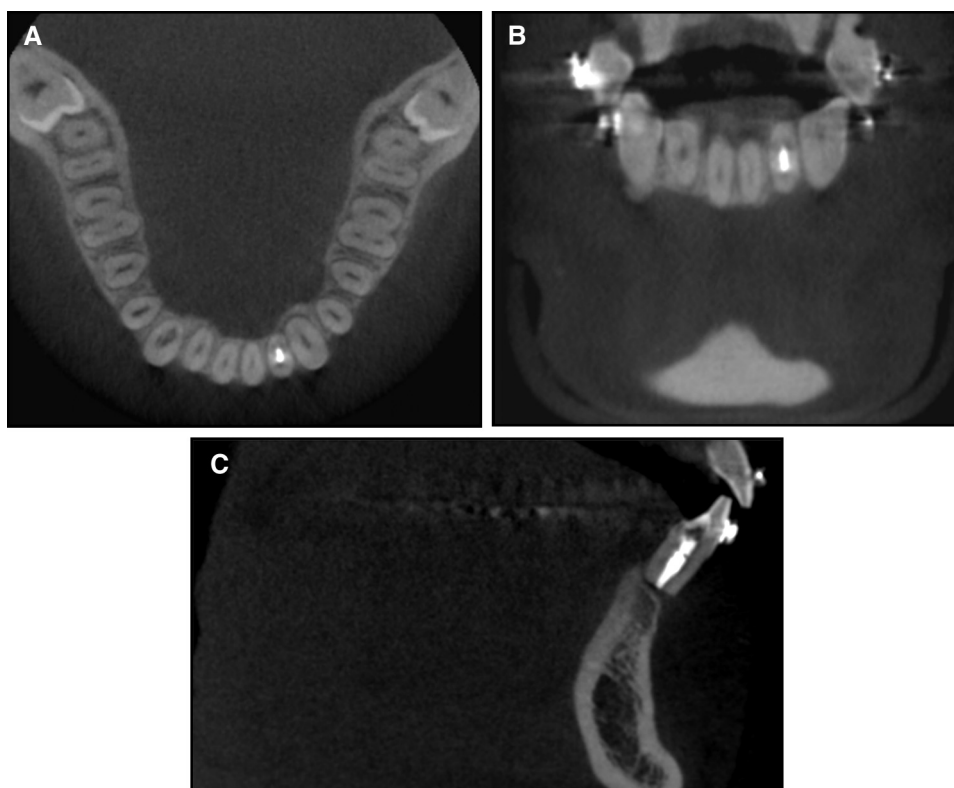
Fig 6. Posttreatment CBCT images of the mandibular left lateral incisor: **A**, the sagittal view; **B**, the occlusal view; **C**, the frontal view on the cervical third of the root showing the bone mainly in the lingual and mesial walls of the tooth.

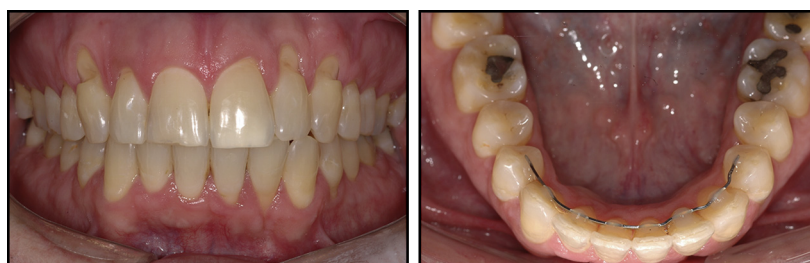
Fig 7. Intraoral 1-year posttreatment photographs.

obtained were totally stable in both clinical or tomographic analyses (Figs 7 and 8).
